Manhole Inspection Summary

Manhole # S17II_013MH

Insp Date: **6/8/07 11:52 AM**

Location Address: **1700 MORELAND-RUXTON**

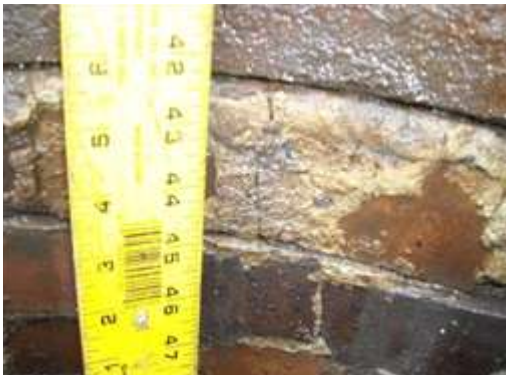
Defect 4

Condition: ☐ Sound ☒ **Cracked** ☐ Root Intrusion ☐ Loose Brick ☐ Deteriorated

Infiltration: ☐ None ☒ **Joint** ☐ Cracks ☐ Mortar ☐ Roots ☐ Wall

CRACK IN CHIMNEY TO THE RIGHT OF THE RULER

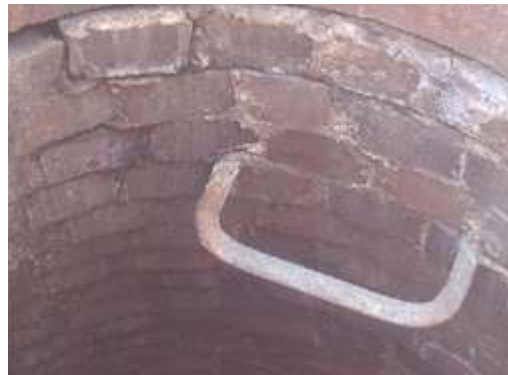
Defect 1

CRACKED CORBEL

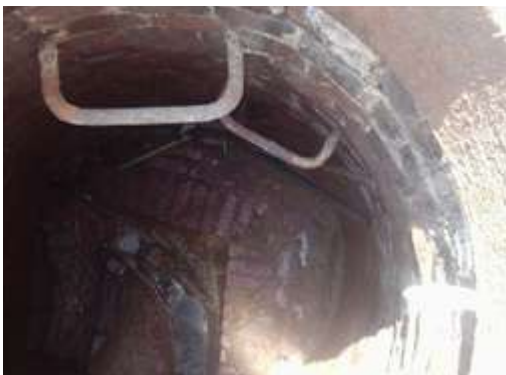
Defect 3

Steps Count: **2** Missing: **0** ☒ **Corroded**

CORRODED STEPS

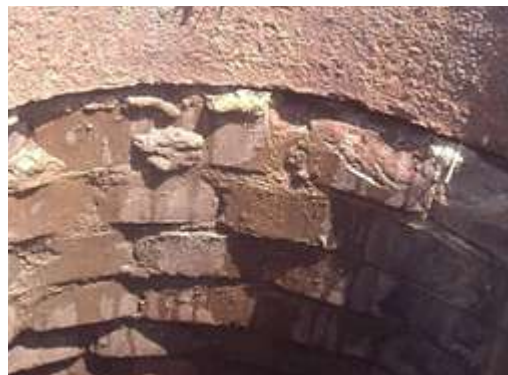
Defect 2

INFILTRATION CORBEL

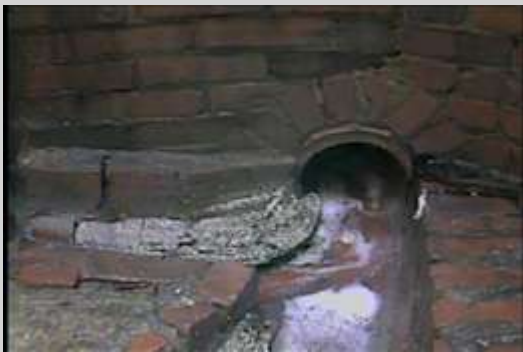
12 O'Clock Outflow

CORRODED STEPS

Pipe Height: **8.4** (in.) Rod and Bar (Angled)
Pipe Material: **Clay** ☐ Pipe Lined
Invert Depth: **8.85** (ft.) Flow Characteristics: **Slow**
Deposits: ☒ None ☐ **Mud** ☐ Sludge ☐ Debris ☐ Grease
Silt Depth: (in.) Deposits Extent:
Infiltration: **None** Pipe Seal Cond: **Sound**

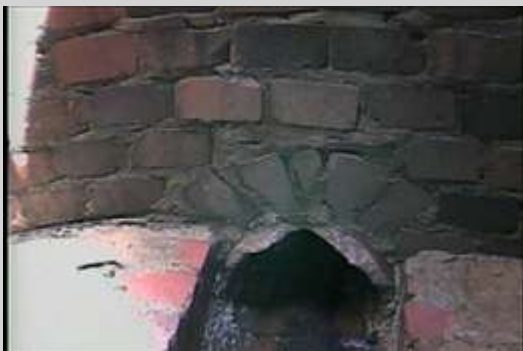
9 O'Clock Inflow

CORRODED STEPS

Pipe Height: **8.4** (in.) Rod and Bar (Angled)
Pipe Material: **Clay** ☐ Pipe Lined
Invert Depth: **8.71** (ft.) Flow Characteristics: **Slow**
Deposits: ☒ None ☐ **Mud** ☐ Sludge ☐ Debris ☐ Grease
Silt Depth: (in.) Deposits Extent:
Infiltration: **None** Pipe Seal Cond: **Broken**

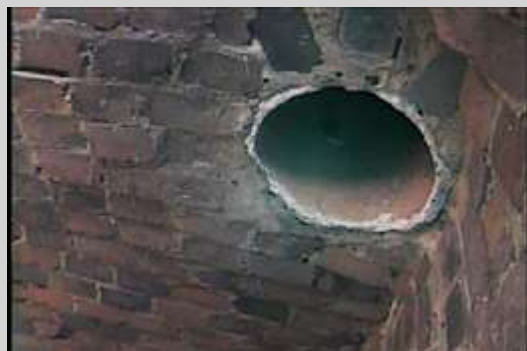
10 O'Clock Inflow

CORRODED STEPS

Deposits: ☐ None ☒ **Mud** ☐ Sludge ☐ Debris ☐ Grease

Silt Depth: **1** (in.) Deposits Extent: **Light**

Infiltration: **None** Pipe Seal Cond: **Broken**

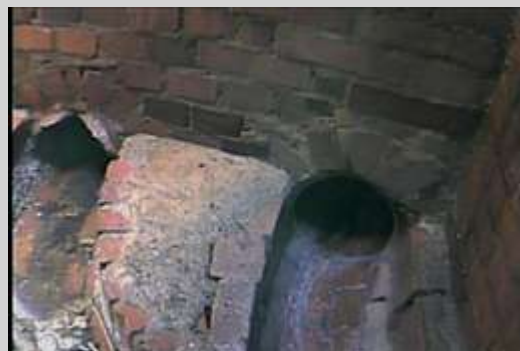
Drop In @ 10 O'Clock

CORRODED STEPS

Drop: **Outside** Rod and Bar

Angled: **Yes** Reading: **7.63** (ft.)

Drop Condition: **Open**
